WV 705 and Maple Drive Intersection Area Pedestrian Safety Study

January, 2024

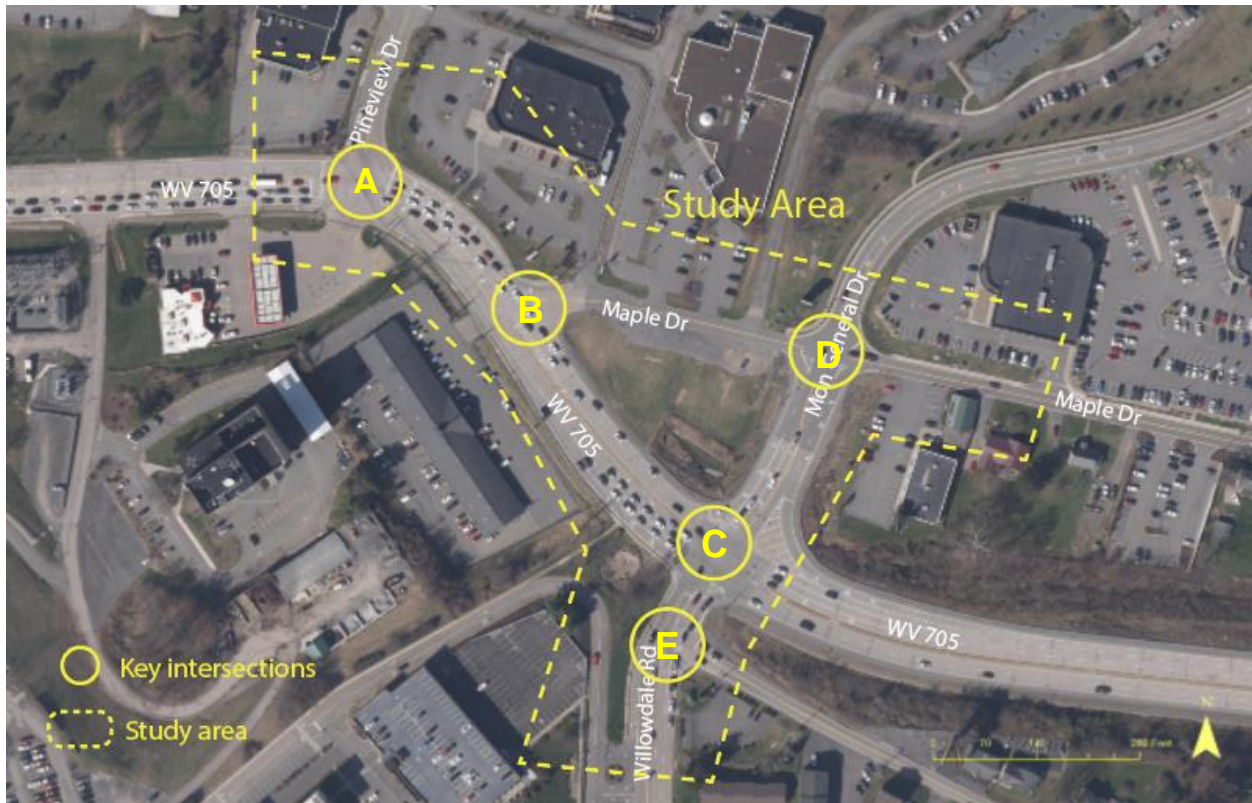
Study Area

Segment	Intersection
WV 705 from Pineview Dr to Mon General Dr Maple Dr from WV 705 to Mon General Dr (Oasis Cafe)	A.) WV 705 and Pineview Dr intersection B.) WV 705 and Maple Dr intersection C.) WV 705 and Mon General Dr D.) Maple Dr and Mon General Dr intersection E.) Willowdale Rd and Chestnut Ridge Rd

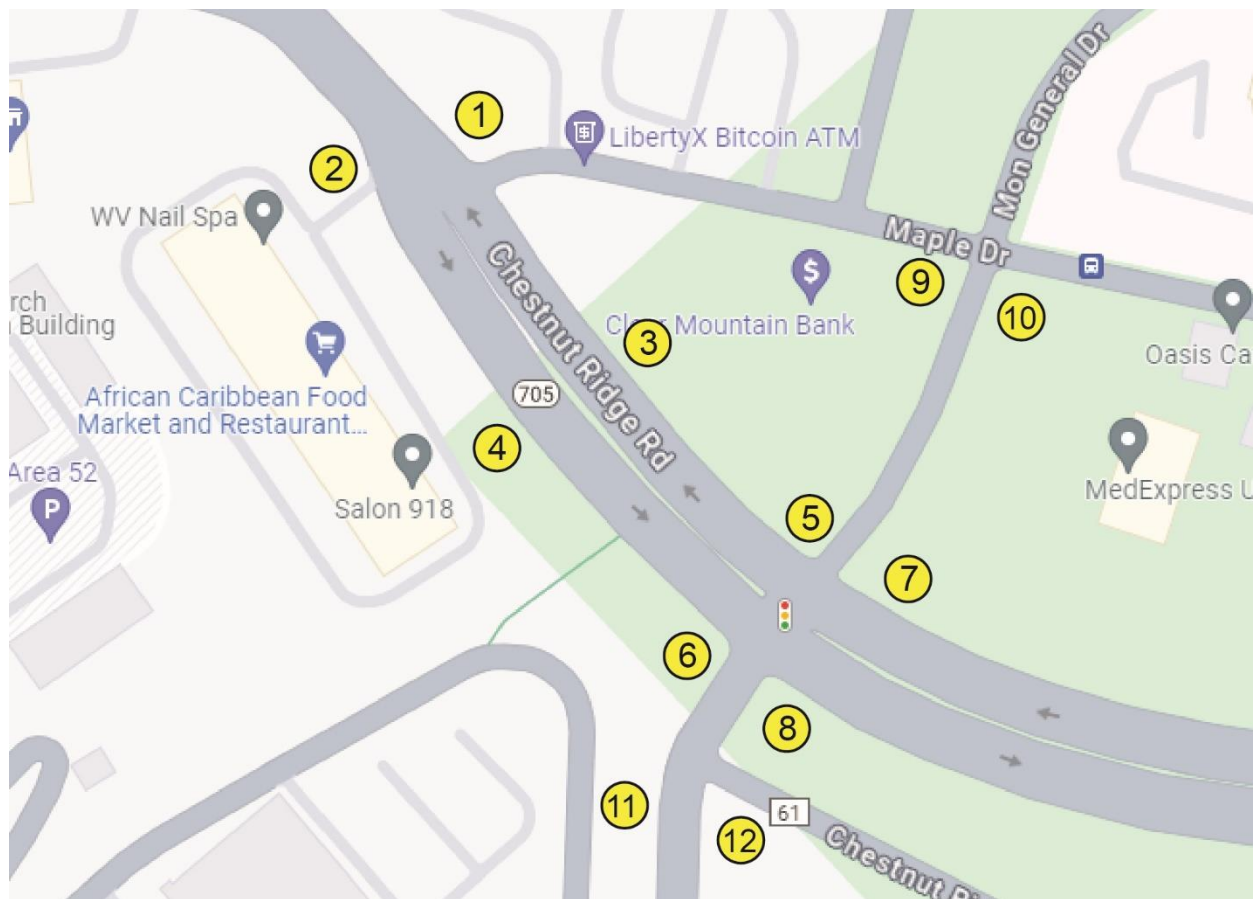
MPO Staff collected data from September 12th through 13th from 9am – 12pm, and 12pm – 4:30pm. Refer to Figure 1 below for locations where data was collected. On September 12th, Staff observed where pedestrians crossed the road at areas 9, 10, 5, 7, 6, 8, 11, and 12. On September 13th, Staff observed where pedestrians crossed the road at areas 2, 1, 4, and 3.

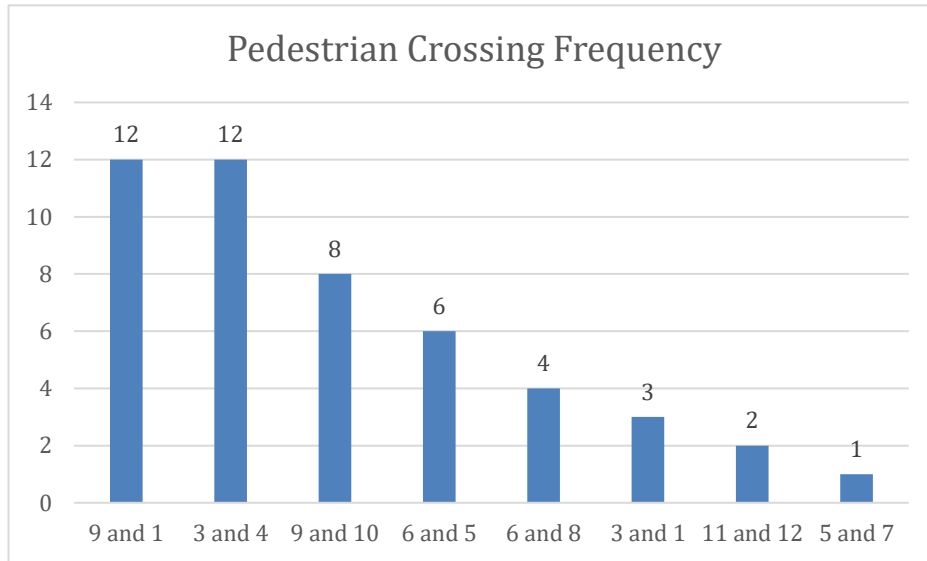
Table 1 illustrates the frequency of pedestrian crossings observed by MPO Staff at specific locations. For instance, between points 9 and 1, Staff identified 12 pedestrian crossings.

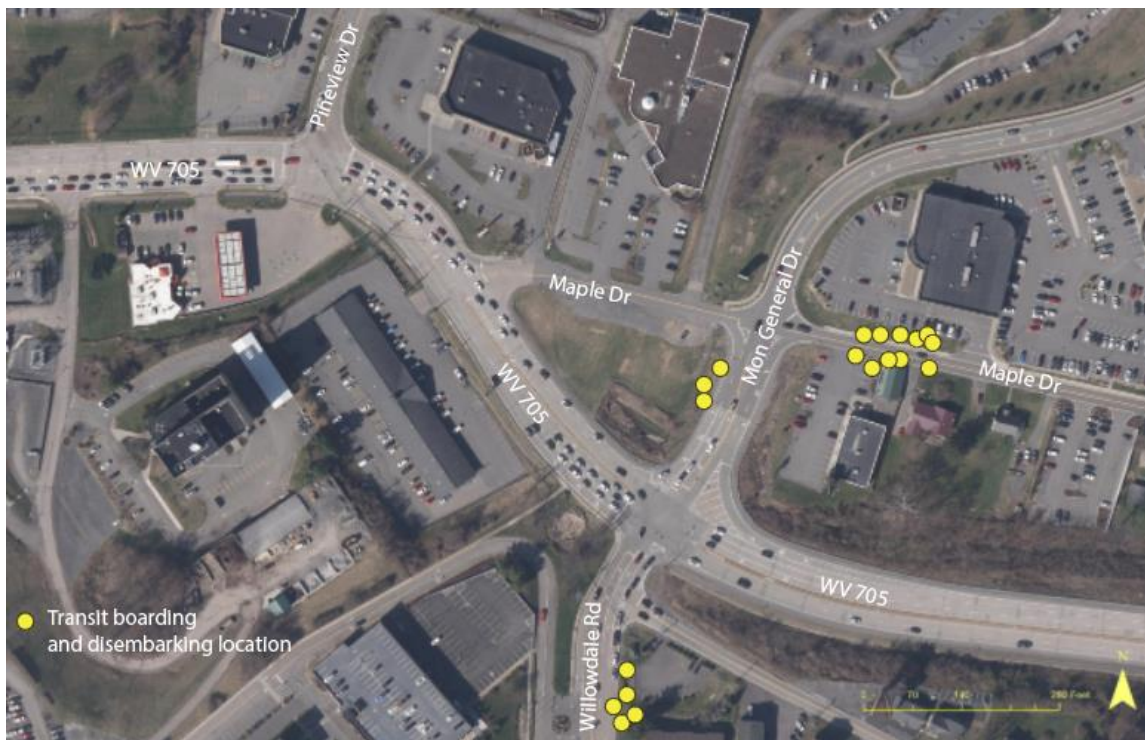
- There were a total of 55 boardings or alightings in the study area for the days observed in the study area, ranging from 1 to 8 boardings or alightings for any day and averaging 5 boardings or disembarks per day for those days.
- The time of boardings and alightings are nearly evenly split in the morning and afternoon.
- The following map shows the locations of boarding and alightings in the study area.

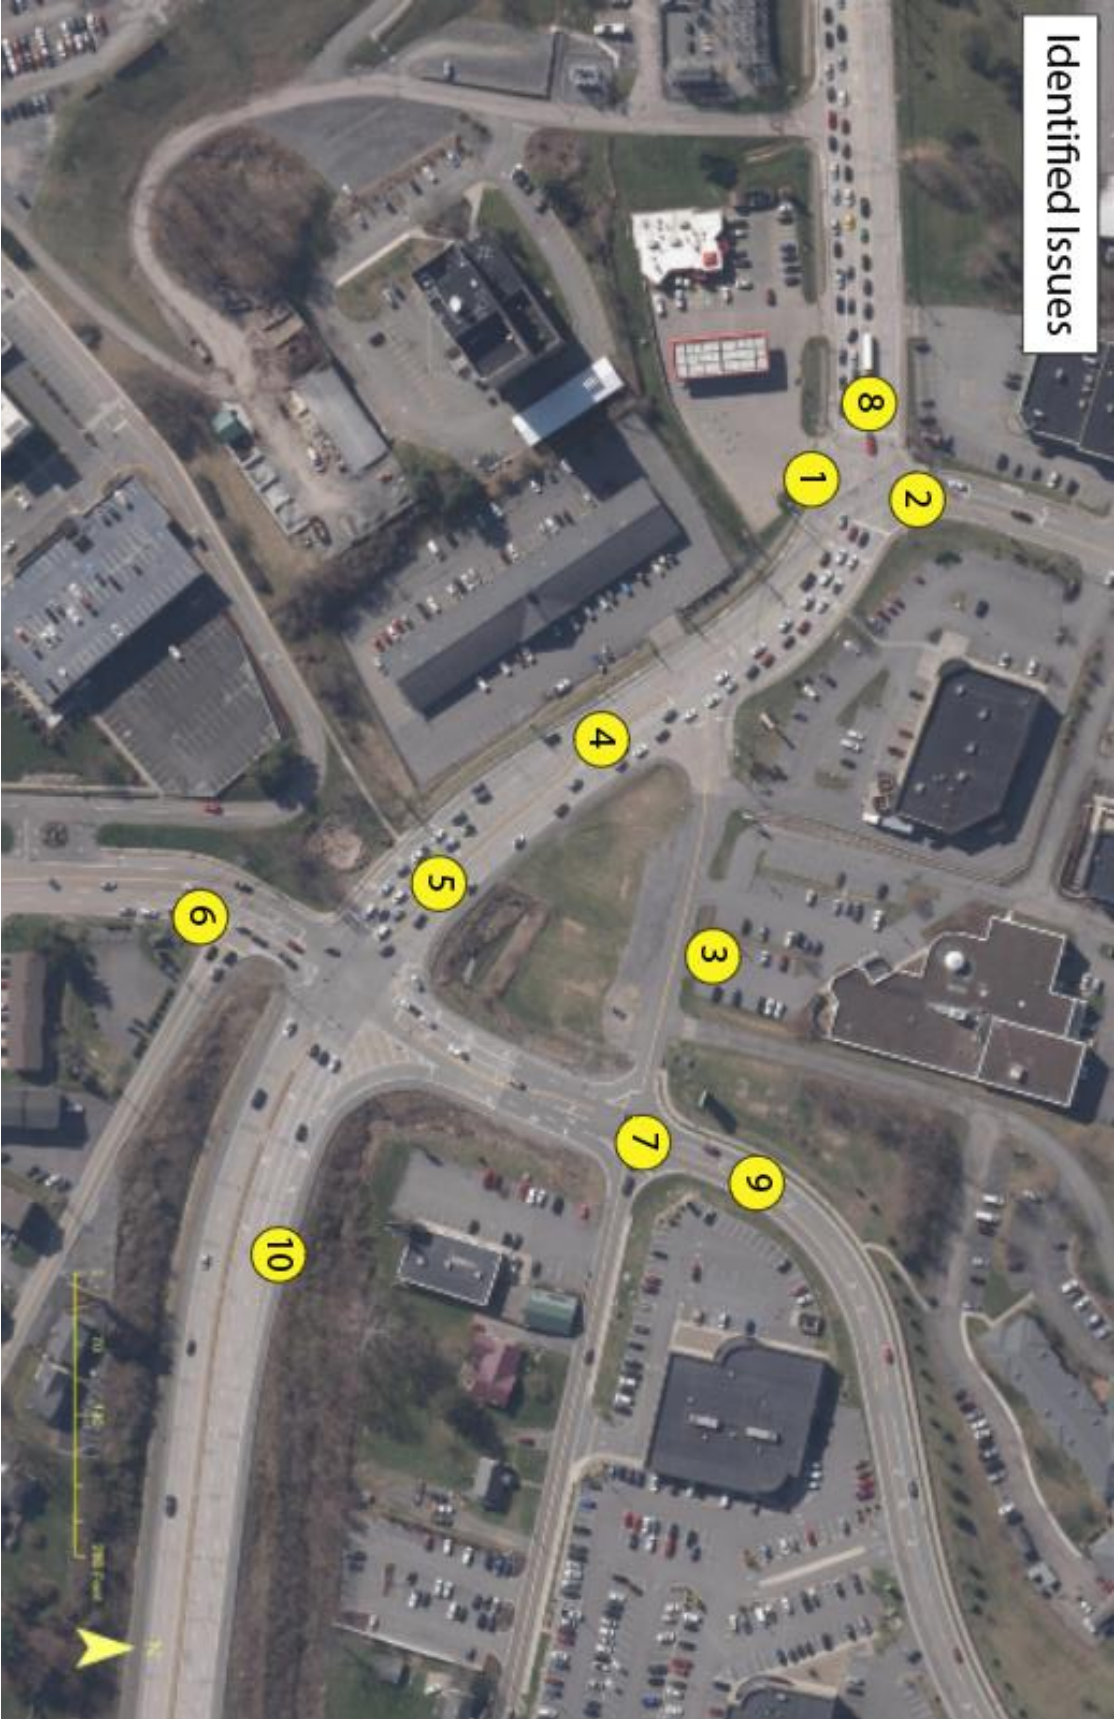
Identified Issues

Location ID (Map on the next page)	Location Description	Issue
1	Driveway to Sheetz Gas Station	No crosswalk or pedestrian signal. A significant volume of pedestrians was observed utilizing the sidewalk on the south side of WV 705, which include crossing at this location.
2	The segment of Pineview Drive at the intersection with WV 705 and Pineview Drive.	No crosswalk or pedestrian signal, however there were sidewalks on both sides of the segment.
3	Maple Dr	Sidewalk disconnected on Maple Dr between WV 705/Maple Dr intersection and Maple Dr/Mon General Dr intersection.
4*	WV 705 near Maple Dr intersection	Pedestrian crossing without crosswalk in high traffic volume location.
5*	WV 705 near Mon General Dr intersection	Pedestrian crossing without crosswalk in high traffic volume location.
6	Willowdale Rd	Pedestrian crossing without crosswalk.
7	The north Mon General Dr leg at Mon General Dr/Maple Dr intersection	Pedestrian crossing without crosswalk.

8	The east WV 705 leg at WV 705/Pineview Dr intersection	At intersections with concurrent pedestrian and vehicle signals, an issue was identified wherein vehicles consistently fail to yield the right of way to pedestrians crossing.
9	North Mon General Dr	Observed speeding.
10	WV 705	Observed speeding.

Location ID (Map on the next page)	Location Description	Improvements
1	Driveway to Sheetz Gas Station	Install crosswalk. Install pedestrian signal and use concurrent pedestrian signal timing with a pedestrian leading phase.
2	The segment of Pineview Drive at the intersection with WV 705 and Pineview Drive.	Install crosswalk with ramps connecting the sidewalks on both sides of Pineview Dr. Install pedestrian activated signal and use concurrent pedestrian signal timing with a pedestrian leading phase.
3	The east WV 705 leg at WV 705/Pineview Dr intersection	Modify pedestrian signal with a pedestrian leading phase.
4	Maple Dr	Construct sidewalk on Maple Dr from WV 705/Maple Dr intersection to Maple Dr/Mon General Dr intersection.
5	The north Mon General Dr leg at Mon General Dr/Maple Dr intersection	Install crosswalk, include traffic calming measures, and add pedestrian warning signs for oncoming traffic.

6	The west Maple Dr leg at Mon General Dr/Maple Dr intersection	Install crosswalk, include traffic calming measures, and add pedestrian warning signs for oncoming traffic.

7	Mon General Dr	Construct sidewalk on the west side of Mon General Dr from the Maple intersection to the WV 705 intersection.
8	WV 705	Install crosswalk. Install on-demand (push button) pedestrian signal and use pedestrian exclusive timing. Tighten turning radius to slow down the speed of turning vehicles.
9	Willowdale Dr	Install pedestrian crossing warning sign. For the long term, install sidewalk on Chestnut Ridge and crosswalk on Willowdale connecting the sidewalk.
10	Bus shelters	<p>Install sister shelters at the steps to Mon Health on Maple Dr. Additional sister shelters are recommended on Maple Dr near its intersection with Poultry Farm Rd, along with stairs to the commercial development on Donahue Dr.</p> <p>(Mountain Lines has identified in their Shelter Plan that resources and funds are available to install the shelters. Permission from the property owner to use the space is needed.)</p>
