WV 7 and Deckers Creek Blvd Intersection Area

Planning Study

Final Report

November 3, 2021

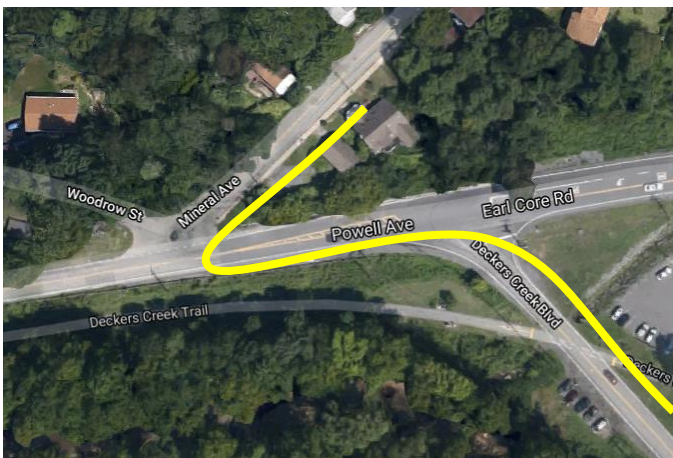
- **Short cut from the Greenbag Rd area to the Mileground/WV 705 area**
Nearly one-third of the NB traffic from Deckers Creek Blvd was to Mineral Ave. While the movement is considered a through movement, it consists of turning left to left turn to WV 7 and turning right to Mineral Ave, as shown in the graphic below. It appears that Deckers Creek Blvd and Mineral Ave is used as a short cut connection between the Greenbag Rd area and Mileground/WV705 area.

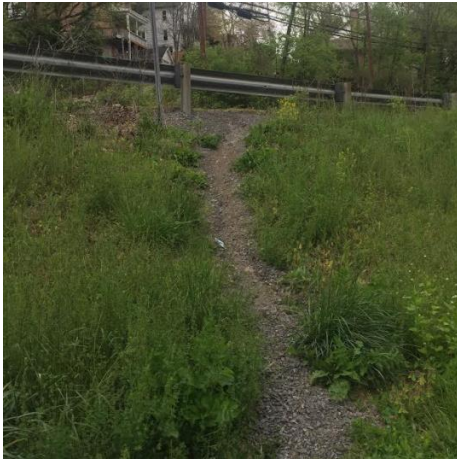
MPO staff observed 47 pedestrians crossing WV 7 near the Mineral Ave intersection during the data collection period. Pedestrians used a make-shift path connecting the shoulder of WV 7 and the trail. The path is shown below.

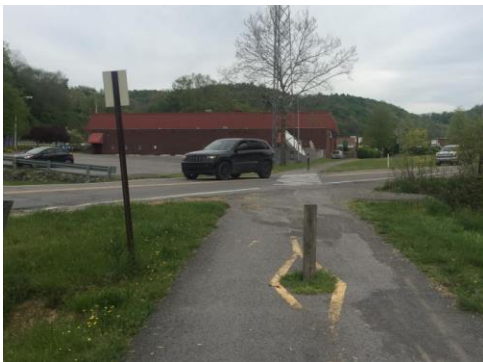
MPO staff observed 168 pedestrians and bicyclists crossing Deckers Creek Rd during the data collection period. The crossing point is shown below.

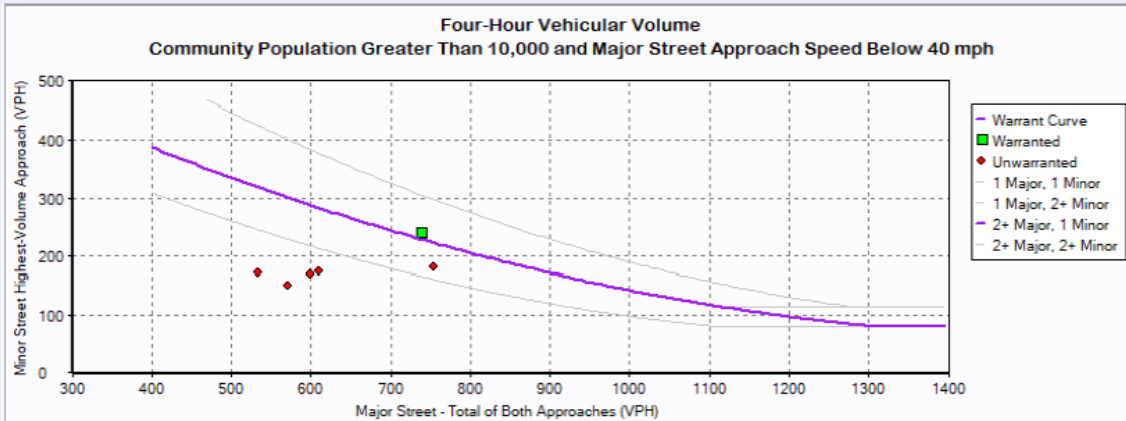
Warrant 2: Four-hour Vehicular Volume

1: WV7-Deckers Creek Blvd-Mineral Ave

Warrant 2 Met? **No**

Notes 1 Hours met (4 required)

MPO staff conducted a warrant analysis for the WV 7-Deckers Creek Blvd-Mineral Ave intersection using the 6-hour traffic volume collected in the fall for the analysis. Based on the Federal 2009 Signal Warrant Standard, the signal warrant was not met. The warrant report is attached to this report.

Note: the warrant was met for 1 hour under the Four-hour Vehicle Volume analysis. The warrant requires 4 hours met to justify the installation of a new traffic signal.
